aiwa

SERVICE TECHNICAL INFORMATION

MODEL : TV-1402KE/2002KE/2102KE

SUBJECT : Part Number of EEP ROM (IC002/NVM3060)

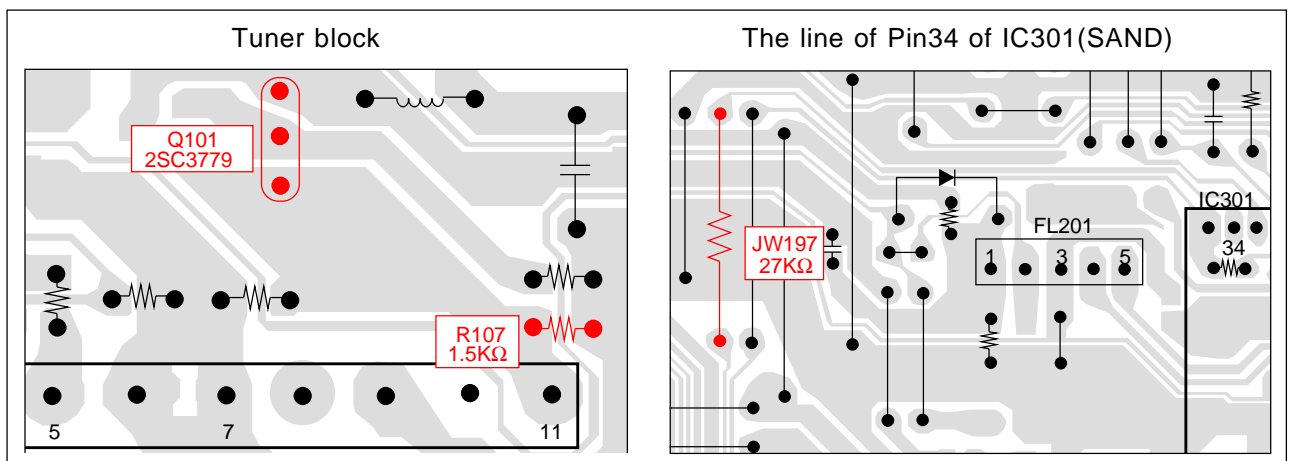
Circuit 2

The improper use of spare parts will be cause of the beat noise on Aerial.
 When the buzz noise arises on Aerial or line input of TV-F21T1(Circuit 1), mount the 27KΩ instead of JW197.
